SITE PRACTICE & TROUBLESHOOTING EFFLORESCENCE

WHAT IS EFFLORESCENCE

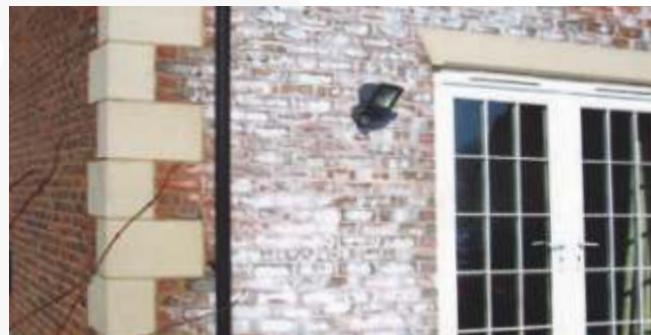
- Bricks should be stacked onto, a clean, firm level surface. They should be protected from rain, mud splashes etc. by covering with waterproof sheeting.
- Turn back the scaffolding board closest to the brickwork at all interruptions to construction.

The first 3 to 5 days after laying (dependent on season), brickwork is most vulnerable to the elements as mortar is still undergoing the hardening process. Newly erected masonry should be covered by waterproof sheeting to protect fresh mortar and open cavities to stop masonry becoming saturated. Hessian is not waterproof. Once the structure is watertight, i.e. roof and windows in place, the building can commence the drying process.
